Manhole Inspection Summary

Manhole # S63I__008MH

Location Address: **5802 Eastern Ave.**

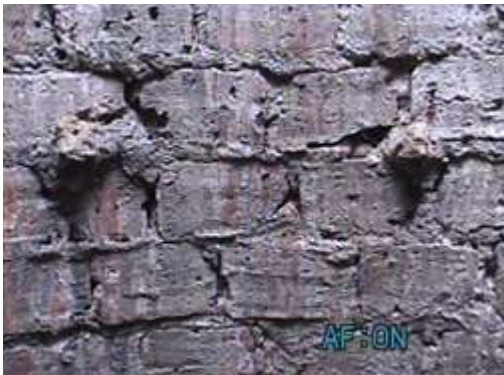
Defect 4

Infiltration: ☐ None ☒ **Joint** ☐ Cracks ☒ **Mortar** ☐ Roots ☐ Wall

loose mortar and joints in chimney

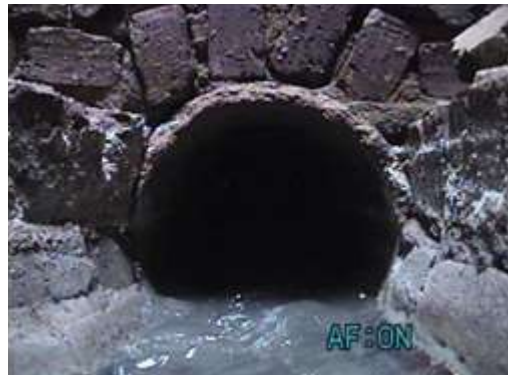
Defect 1

19 pipe seal broken and cracked from 8 o'clock to 11 o'clock

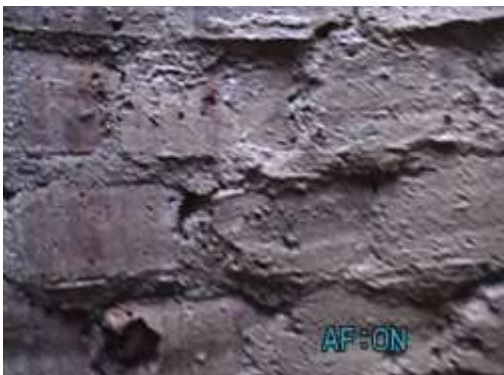
Defect 3

Parged wall deteriorating

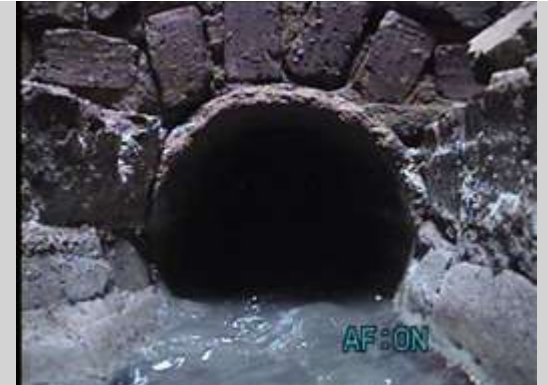
12 O'Clock Outflow

10 in. Circular Gravity Sewer
Pipe Out @ 12 O'Clock

Pipe Height: **10.8** (in.) Rod and Bar (Angled)
Pipe Material: **Clay** ☐ Pipe Lined
Invert Depth: **14.08** (ft.) Flow Characteristics: **Slow**
Deposits: ☒ None ☐ Mud ☐ Sludge ☐ Debris ☐ Grease
Silt Depth: (in.) Deposits Extent:
Infiltration: **None** Pipe Seal Cond: **Sound**

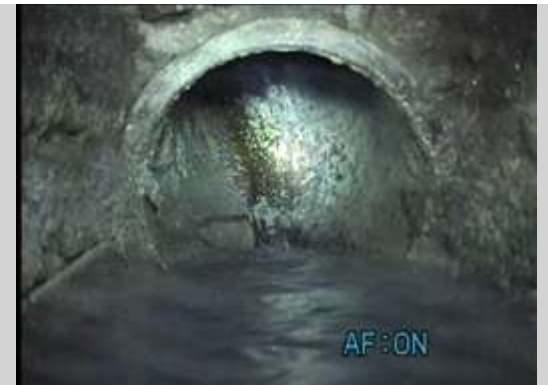
6 O'Clock Inflow

8 in. Circular Gravity Sewer
Pipe In @ 6 O'Clock

Pipe Height: **8.4** (in.) Rod and Bar (Angled)
Pipe Material: **Clay** ☐ Pipe Lined
Invert Depth: **13.75** (ft.) Flow Characteristics: **Slow**
Deposits: ☐ None ☒ **Mud** ☐ Sludge ☒ **Debris** ☐ Grease
Silt Depth: **2** (in.) Deposits Extent: **Medium**
Infiltration: **None** Pipe Seal Cond: **Sound**

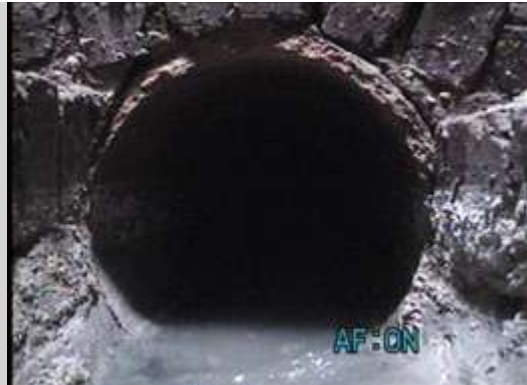
9 O'Clock Inflow

10 in. Circular Gravity Sewer

Pipe In @ 9 O'Clock

Infiltration: **None** Pipe Seal Cond: **Broken**
